HEADQUARTERS STRATEGIC AIR COMMAND
DIRECTORATE OF AIRCRAFT MAINTENANCE
AIRCRAFT ENGINEERING DIVISION
(Hq SAC/LGME)

ENGINEERING REPORT NO. P-206

TF30-P-7 INSTALLED TRIM CORRECTION

14 January 1977

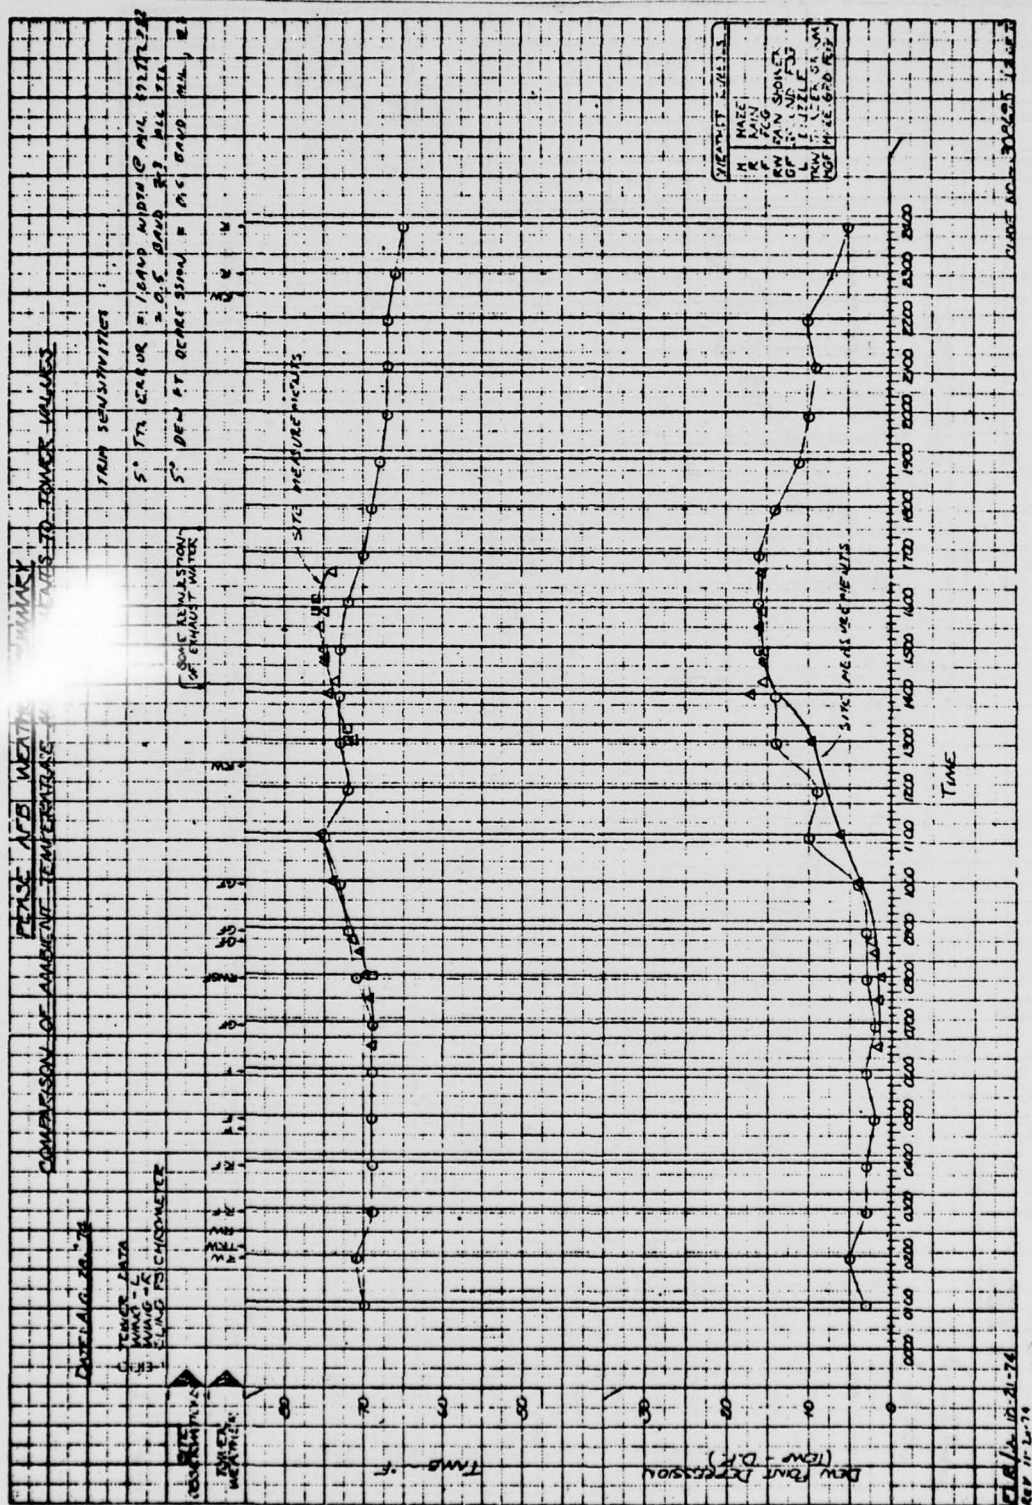
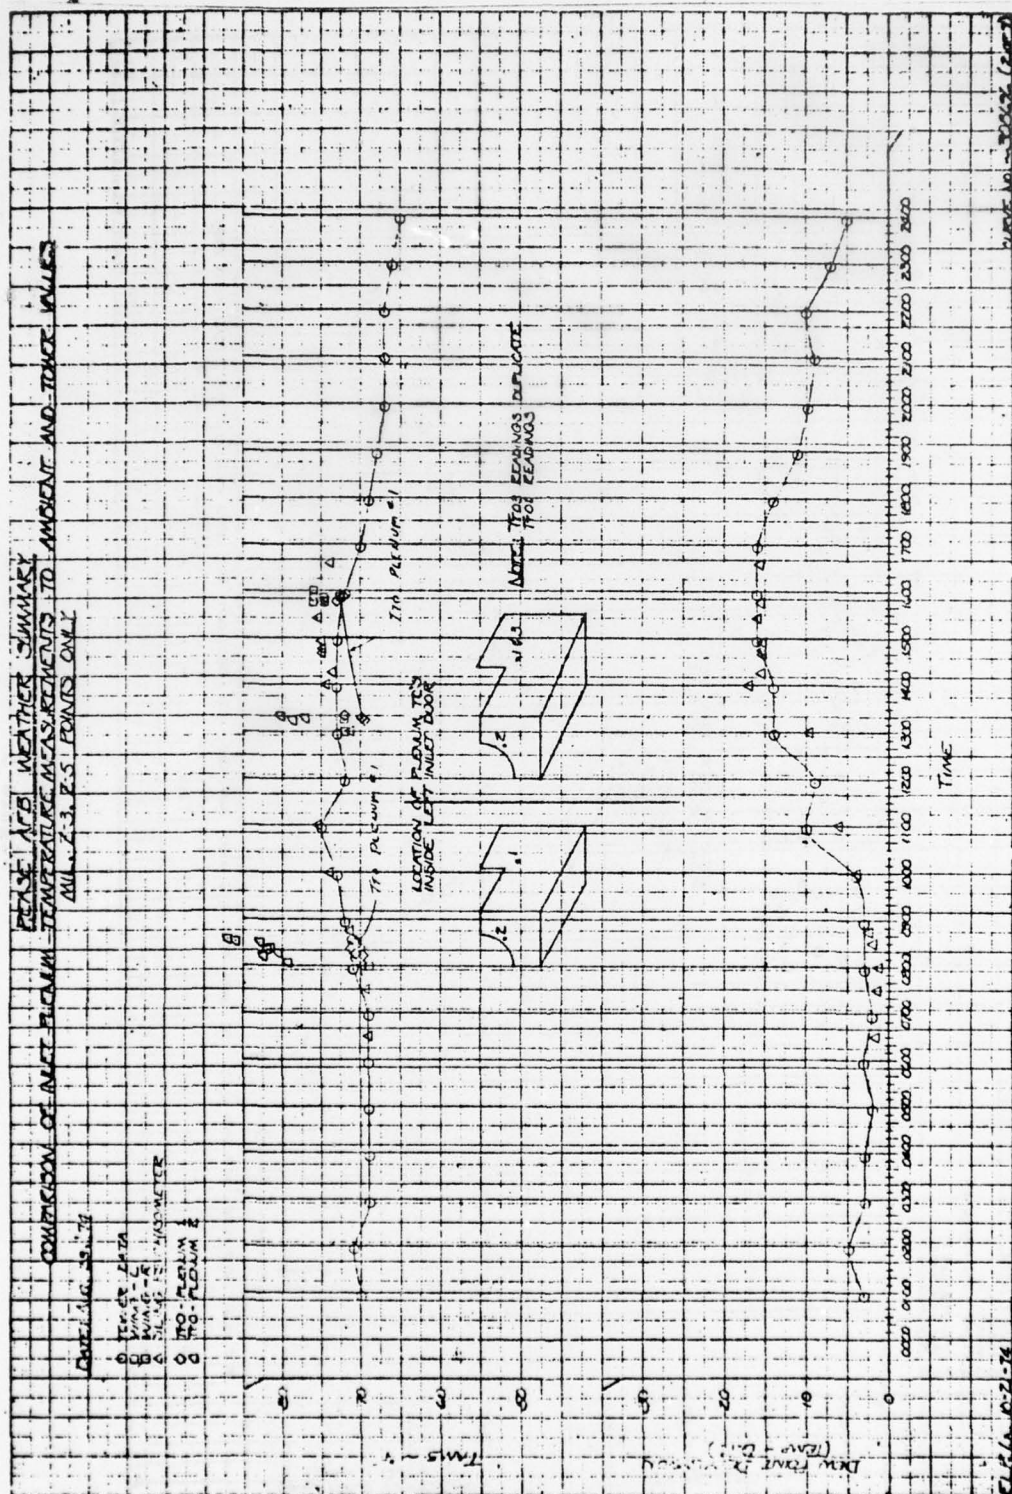
(3) Significant differences were noted between temperature and dew point readings recorded at the base weather observation point and those recorded at the power check pad. See Figures 2, 3, 4, and 5 for examples. The desired engine performance is calculated based on ambient conditions existing at the time of the engine trim run. A deviation of 5°F temperature between what is measured and what goes into the engine

will cause an apparent performance change of a military trim band magnitude. A 5°F dew point deviation will cause a change of 1/2 military trim band magnitude.

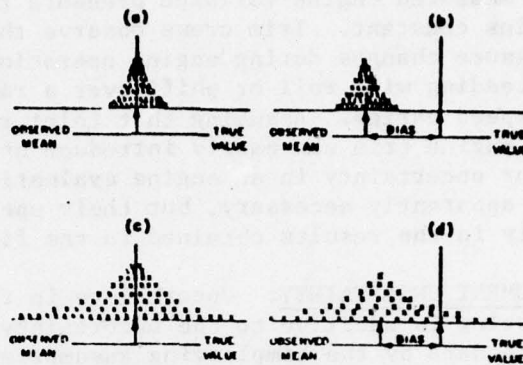
Fig. 1 Accuracy, precision, and bias

5. ACCURACY, PRECISION, AND BIAS: A quick appreciation for the meaning of the words accuracy, precision, and bias (or systematic error) can be obtained by viewing Figure 1. The observations plotted in Figure 1(a) are precise and unbiased. In Figure 1(b) the observations are precise and biased. In Figure 1(c) the observations are imprecise but unbiased, and in Figure 1(d) the observations are both imprecise and biased. Precision has to do with the scatter of the observations about a point of central tendency. Bias is the difference, if any, between the true value (TV) and the mean of the observations. Accuracy is a more general term, encompassing both the concepts of precision and bias. The least accurate observations are those found in Figure 1(d), the most accurate in Figure 1(a).

6. INSTRUMENT VARIATION: The illustrations on Figure 1 show that an instrument usually does not repeat exactly on repeated observations.

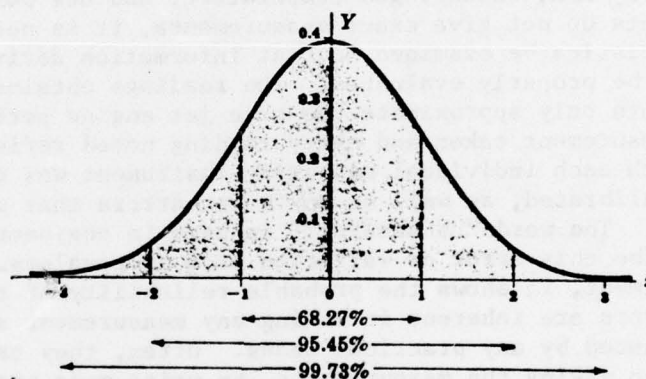
Fig. 2 THE NORMAL DISTRIBUTION

7. RANDOM ERROR DISTRIBUTION: The Gaussian (or normal) distribution is the familiar bell shape curve of statistics which represents the frequency distribution function derived from study of a large number of random unrelated events (see Figure 2). It is used in statistics as the description of random events and, therefore, as the basis for establishing confidence intervals in sampling. (An engine trim represents a single sample of engine performance from the performance distribution for the engine and test instrumentation.) A statistical term, standard deviation (SD), associated with any distribution is the measure of the width of the bell curve about the mean for a given set of data. A measure of scatter or imprecision of repeated measurements is provided by the square of the standard deviation. This is the variance in a series of observations and defined as the mean of the sum of the squares of the deviations of observations from their average. The percent of total observations in the distribution that fall within a given amount or interval of the mean can be predicted if the standard deviation is known. For example, 68.3% of all readings in a normal distribution will fall between plus and minus one SD, 95.4% will fall between plus and minus two SDs, and 99.7% will fall between plus and minus three SDs. Likewise, knowing the standard deviation, we can also define the percentage of total observations that fall within any specified error interval. For example, for a commonly used "confidence interval" of 90%, a normal distribution would have 90% of all errors equal to or less than 1.645 standard deviations. Another

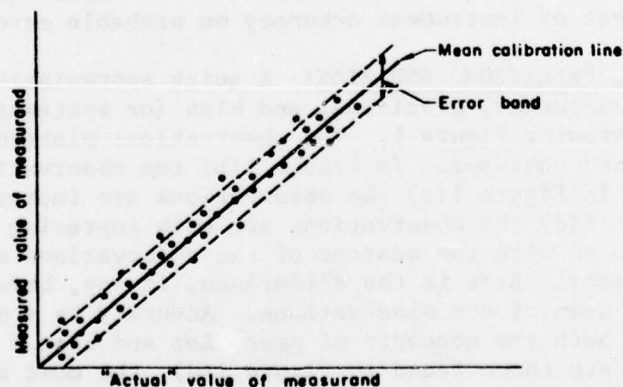
Fig. 3
System accuracy defined as the relationship between the measured value of a parameter and its "actual" value (see text).

8. CALIBRATION: Assume, for the moment, that a precision measuring equipment laboratory (PMEL) is calibrating a test cell instrument against a standard with a known actual value of the measurand. The instrument's accuracy is determined by observing the standard measurand over a repeated number of observations at each calibration point. This assumed procedure of repeat observations is different from present PMEL procedure which requires only a single reading at each point. The observed values plotted against the "actual" values would probably give a picture like the set of points marked as dots of Figure 3. Through this set of points, a mean line can be fitted by various procedures. This is called a calibration line. About this calibration line, there is a scatter of points representing the various sources of error in the observation process. In general, the points will have a Gaussian or normal distribution about the mean line. The plot of observations from the PMEL calibration points shows that a certain percentage of the total number of the discrete observations points fall within a given error band, illustrated by the two dashed lines on Figure 3. A wide band would take in almost all the points, and a narrow band might take in only a few. The accuracy of the instrument can now be defined in terms of: (a) any bias error (represented by one minus the tangent of the mean calibration line times the "actual" value), (b) the width of the random error band, and (c) the stated percentage (confidence interval) of a large number of observations that would fall within the given error band.
